Manhole Inspection Summary

Manhole # S21A__050MH

Insp Date: **9/14/07 9:56 AM**

Location Address: **1616 SUMMIT ST**

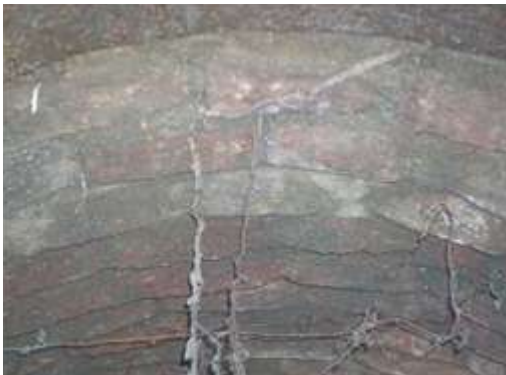
Defect 3

Condition: ☐ Sound ☐ Cracked ☒ **Root Intrusion** ☐ Loose Brick ☐ Deteriorated

ROOT INTRUSION OF THE CORBEL

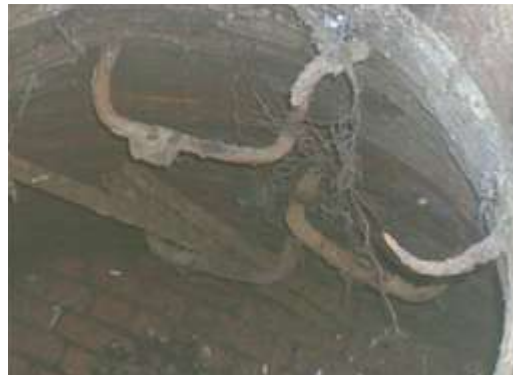
Defect 2

Count: **3** Missing: **1** ☒ **Corroded**

CORRODED AND MISSING STEPS

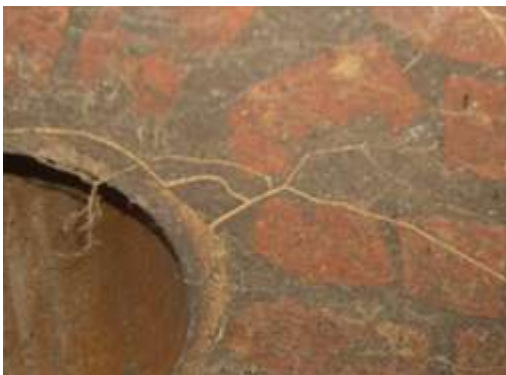
Defect 1

Condition: ☐ Sound ☐ Cracked ☒ **Root Intrusion** ☐ Loose Brick ☐ Deteriorated

ROOT INTRUSION

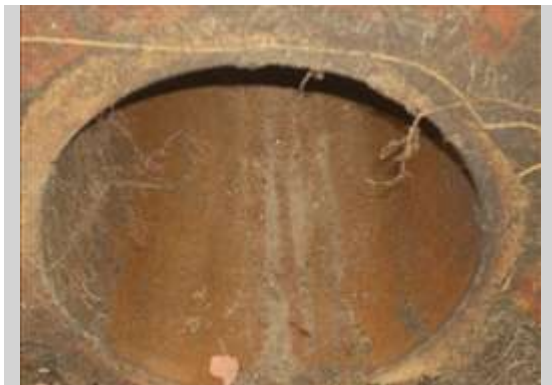
12 O'Clock Outflow

Infiltration: **None** Pipe Seal Cond: **Roots**
